INDOOR AIR QUALITY ASSESSMENT

**Sunderland Elementary School
1 Swampfield Drive
Sunderland, Massachusetts**

Prepared by:
Massachusetts Department of Public Health
Bureau of Environmental Health
Indoor Air Quality Program
December 2018

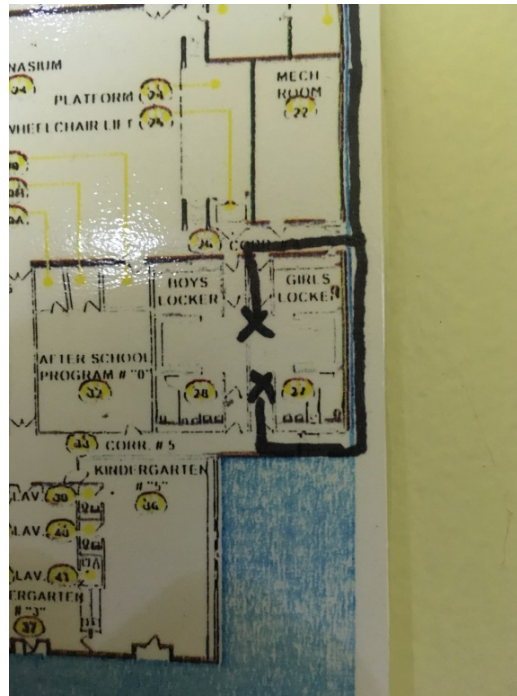
Picture 1

After the summer of 2018, mold growth was visible in the PT/OT room. The OT/PT room is a converted girl's locker room (Picture 1), as is the adjacent storeroom. Both areas have former shower rooms with open, disused drains (Picture 2) that likely have dry drain traps. The purpose of a trap is to prevent odors, and other pollutants from migrating from the sewer system into interior space. Without water in the trap, water vapor from the sewer can readily enter the former locker rooms and moisten porous materials to cause mold growth in such materials as wall-to-wall carpeting in a section of the former boy's locker room (Picture 3). Of note were musical instrument cases that appeared mold-colonized (Picture 4). A number of classrooms had warped corkboard (Picture 5) as well as bowing ceiling tiles, which indicates exposure to water vapor during hot, humid weather. Also noted were paper bags stored directly on the floor in the boy's locker room (Picture 6), which can become moistened during summer months due to condensation on cool surfaces.

Location of OP/PT room and storage in former locker rooms

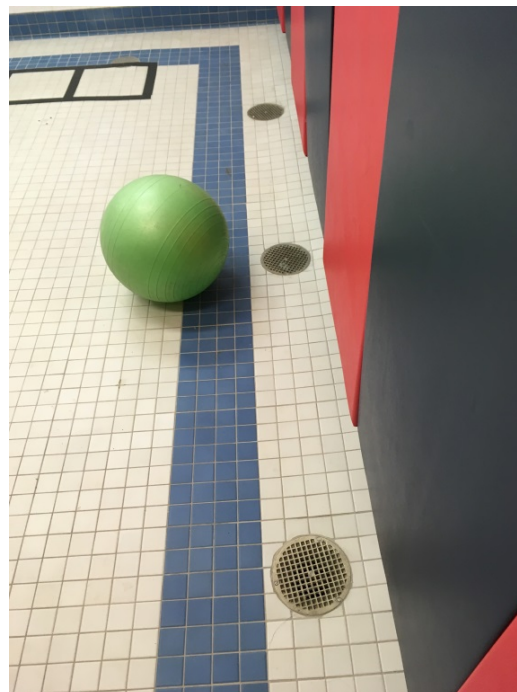
Picture 2

Open drains in OP/PT room

1. Seal all floor drains in the former locker rooms with an air tight plate.
2. Remove carpet in the former boy's locker room and GW in Picture 7 in a manner consistent with recommendation delineated in the US EPA guideline "Mold Remediation in Schools and Commercial Buildings", available at: <http://www.epa.gov/mold/mold-remediation-schools-and-commercial-buildings-guide>. It is not recommended to use carpeting in this location.

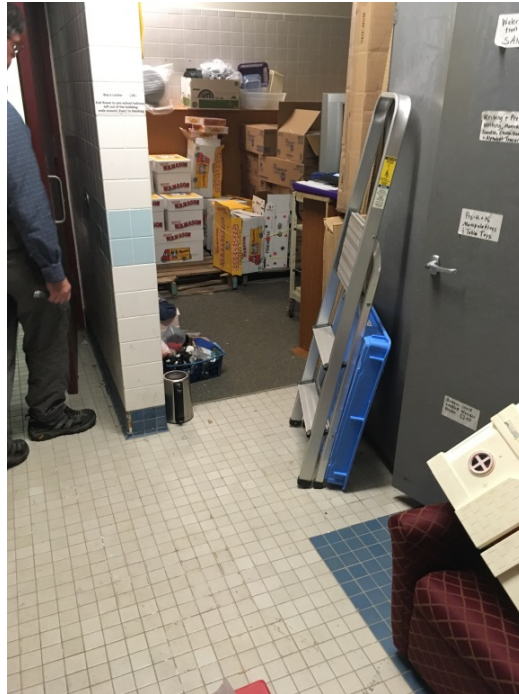
Picture 3

Wall-to-wall carpeting in store room in former boys' locker room

1. Consider replacing wall-to-wall carpeting with a flooring material that is resistant to mold growth.

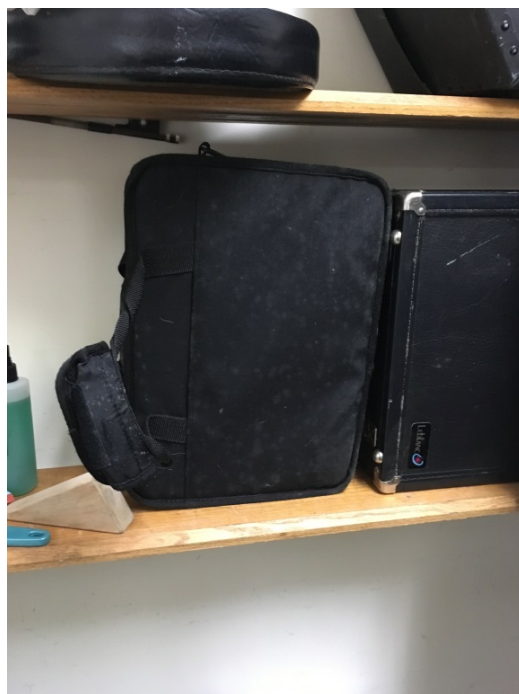
Picture 4

Mold-contaminated instrument cases

3. Replace mold-colonized instrument cases.
4. Ensure stop cock in Picture 7 is replaced/repared.
5. Refrain from storing cardboard boxes directly on floors or in other locations with chronic moisture to prevent moistening/mold growth.

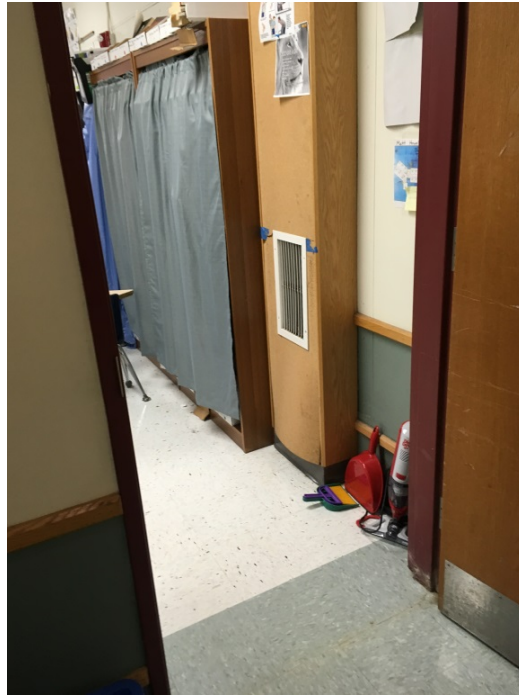
Picture 5

Warped cork board in classroom

6. Remove water-damaged cork board as needed.
7. Replace water-damaged ceiling tiles after leaks are discovered and repaired. During summer months closely monitor conditions of excess relative humidity (e.g., > 70% for extended periods of time) to prevent condensation/mold growth. Operate AC systems/dehumidifiers as needed.

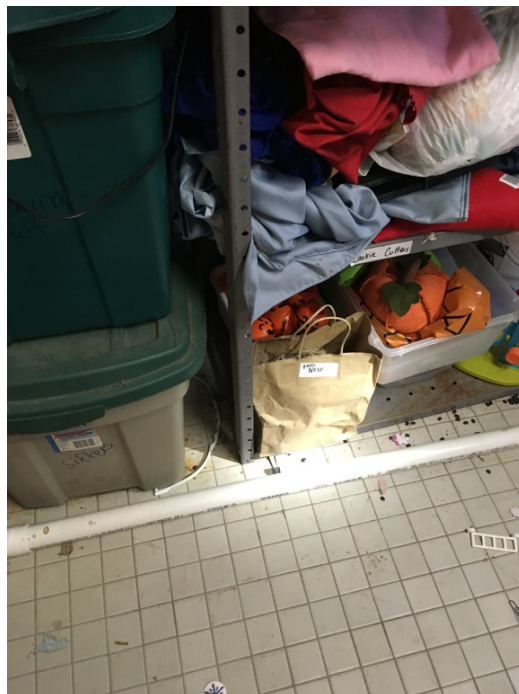
Picture 6

Paper on floor of storeroom

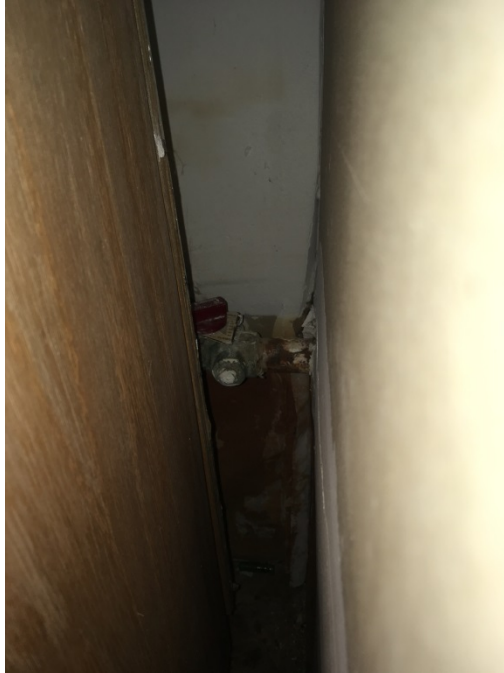
Picture 7

One room had water-damaged gypsum wallboard (GW) that is attributed to a failed/leaking stop cock. Chronically moistened GW can support mold growth.

Reportedly leaking stopcock, note water-damaged gypsum wallboard
